Investigation Report: Failure of Combustion Chamber in a Turbojet Engine

**Ram Evron, Albert Levi & Moshe Shapira.,
Bet-Shemesh Engines,
Bet-Shemesh, Haela, 99000 ,Israel.**

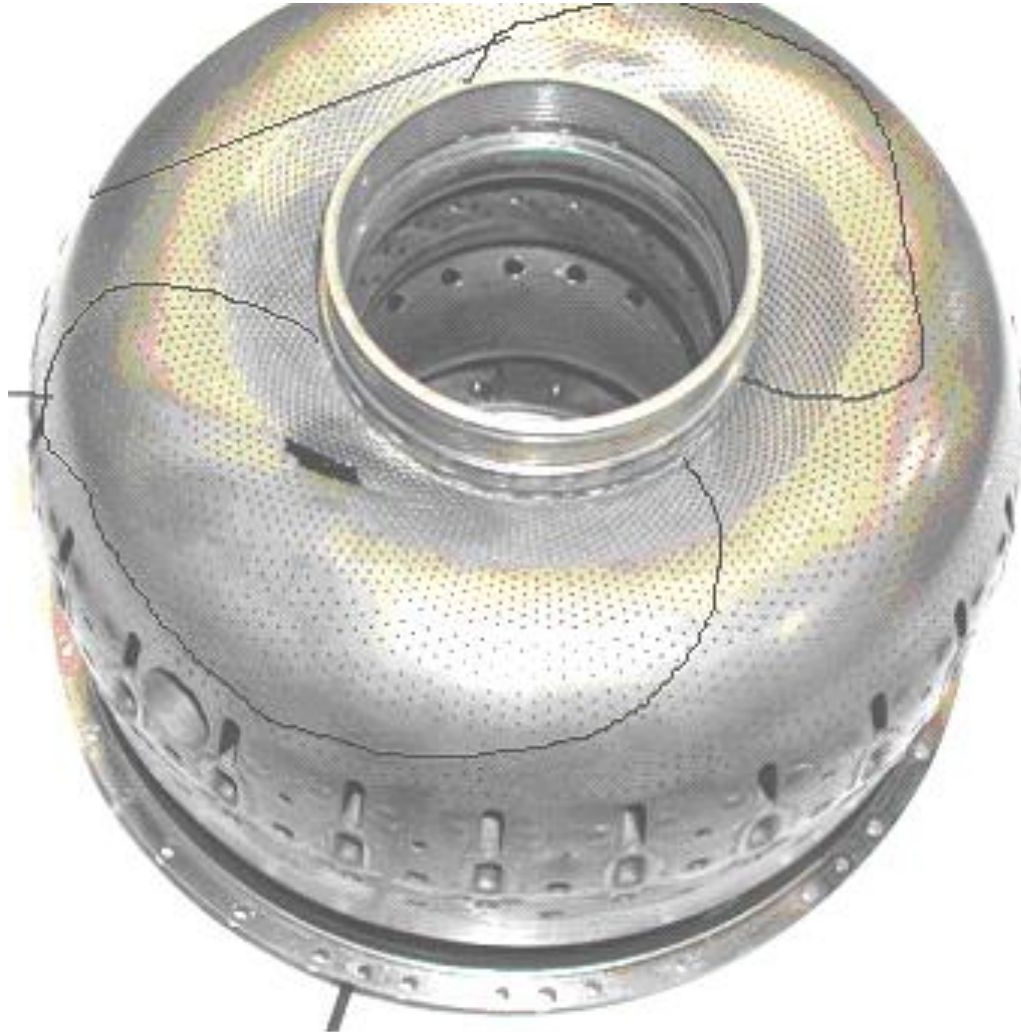
The Combustion Chamber & the Microstructural Damage Images

- **The chamber raw material is NIMONIC 75 (Ni – base alloy with melting temperature around 1360 °C). Fuel ignition is performed by using pyrotechnic igniter or by High Energy ignition.**
- **After operation of 5 and 41 minutes, structural damages consisting of cracks, deformations and pores appeared in the inner wall of the combustion chamber in front of the pyrotechnic igniter aperture (see sketch).**

- **A sample from the defected region was sent to the metallurgic laboratory (Bet Shemesh Engines).**
- **Using X-Ray Fluorescence (XRF) technique, it was found that Aluminum oxide deposits were covering the sample, causing partial clogging of the air passages (0.75 mm holes). It was postulated that the clogging of the air passages led to the development of high localized temperatures loads that caused the damage.**
- **The existence of the Aluminum oxide deposit was attributed to the pyrotechnic igniter which utilizes Aluminum powder to locally increase temperatures in the combustion chamber.**
- **Later, it was found that cracks, pores and severe microstructural damage were formed in combustion chambers which were not exhibited pyrotechnic ignitions.**

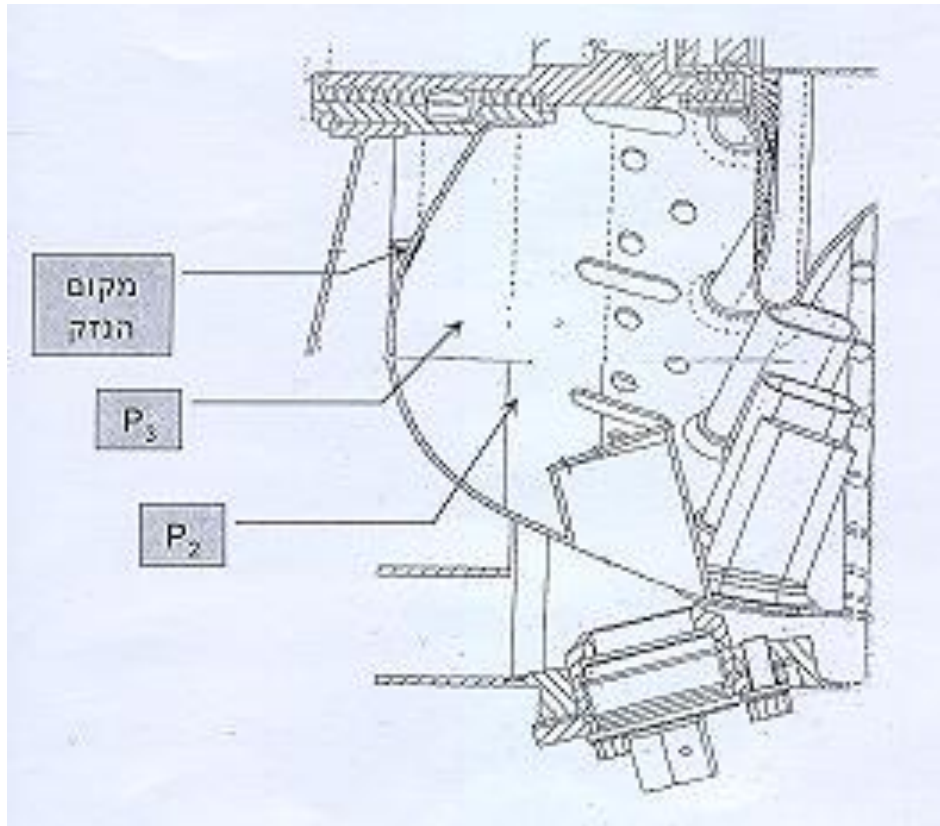
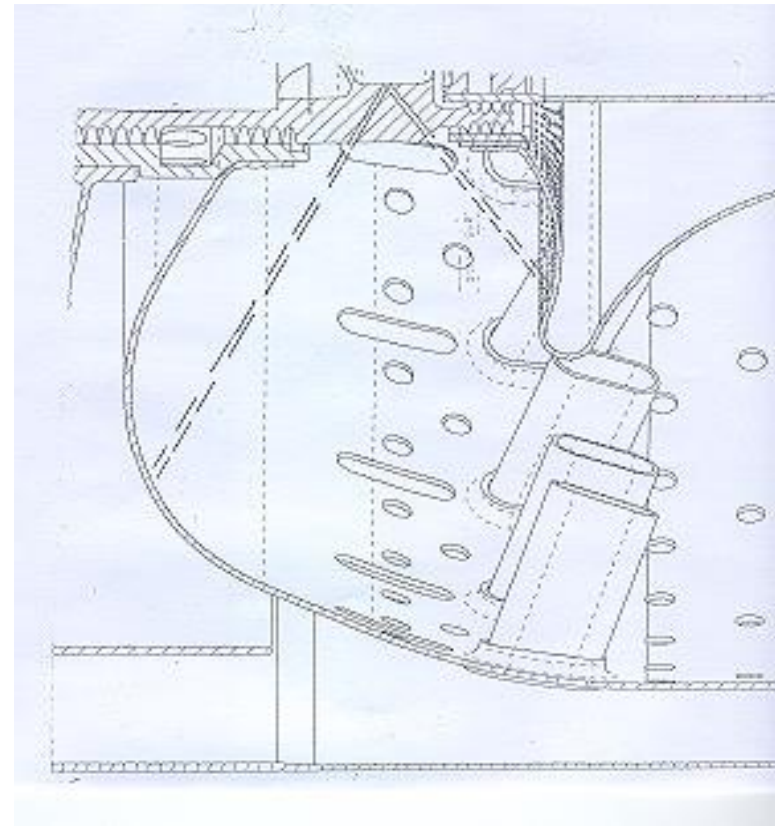
Sketches of the Combustion Chamber & the Damage Location

- **Further examination of the failed combustion chambers revealed that in all of these chambers during operation only a single pyrotechnic igniter was installed while in the other side pressure and temperature gauges were installed.**
- **This installation, as we suspect, initiate a jet of air to enter through the opening between the gauges and the combustion chamber causing flame deflection to the combustion chamber walls due to unsymmetrical air flow.**
