**The 11th Israeli Symposium on
Jet Engines and Gas Turbines (25 October, 2012)**

CONTINUED AIRWORTHINESS OF AIRFRAME / ENGINE INTERFACES

Based on study performed in
Cranfield University, England

Israel Aerospace Industries

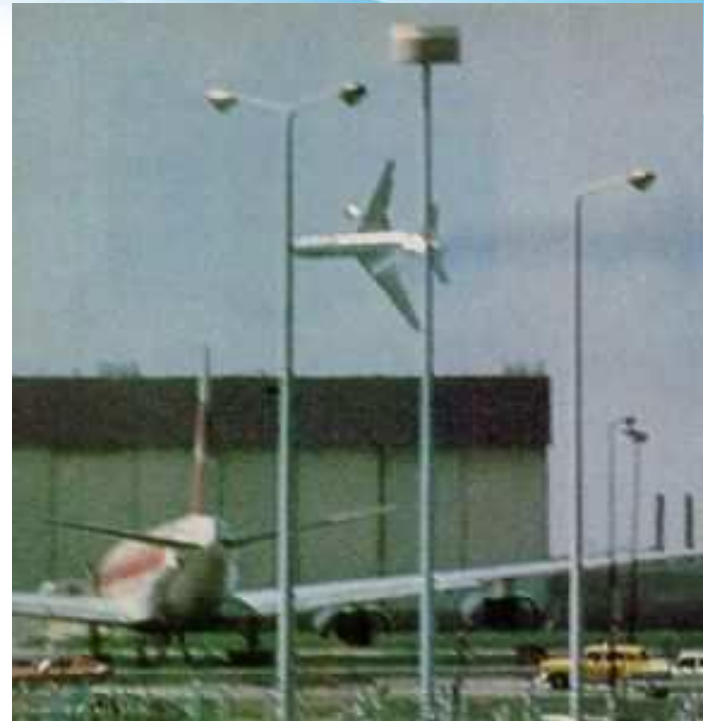
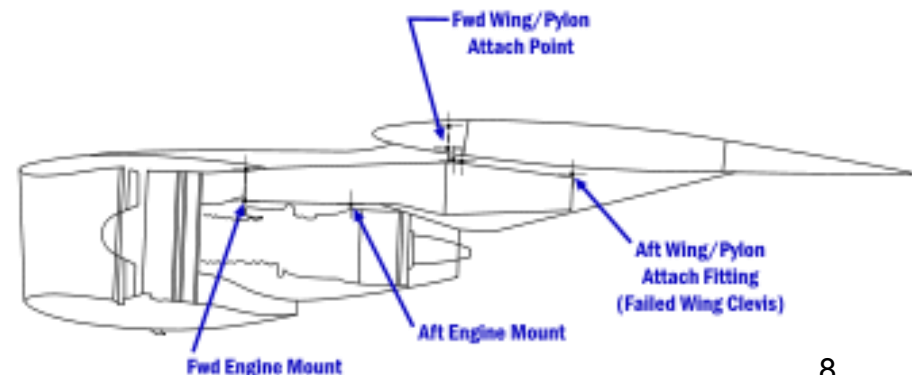
Case #1: DC-10, May 25, 1979, Chicago

On May 25, 1979, DC-10 (American Airlines, Flight 191) took off from Chicago, O'Hare Airport. While the aircraft was banking, both left engine and strut assembly have separated from the wing. The pylon separation resulted in corresponding hydraulic lines severance. Thus, a loss of associated hydraulic pressure and retraction of all slats outboard of the left engine, were caused consequently. The resulting lift asymmetry led to a loss of control of the aircraft. Finally, the aircraft overturned and crashed.

American Airlines mistakenly assumed that it is acceptable to remove/reinstall engine and pylon together. Based on such assumption, forklift was used for maintenance procedures and caused unintended structural damage during engine/pylon reinstallation. The damage led to the separation of the engine and pylon assembly at a critical point during takeoff.

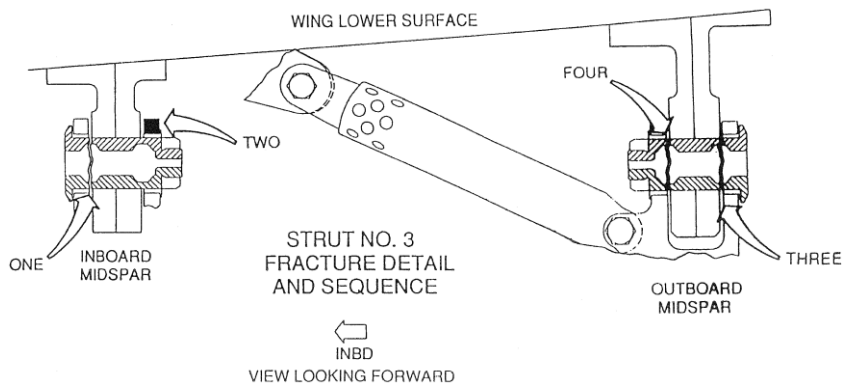
Strut number 3 fracture details and probable separation sequence

The initial failure occurred in the number 3 engine strut. The failure of inboard midspar fused pin, resulted in a ductile fracture of the inboard midspar fitting outboard lug. Subsequent failure occurred in the upper link, then in the diagonal brace. According to manufacturers' assumption, the strut should safely separate from the wing and fall away from the aircraft or rotate over the wing. Instead, the separated number 3 engine travelled in outboard direction, impacted the number 4 engine, and caused the breakaway of this engine and its strut from the aircraft.

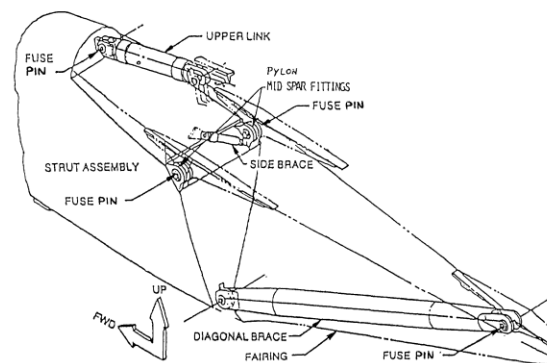
Pylon to wing attachment RH wing

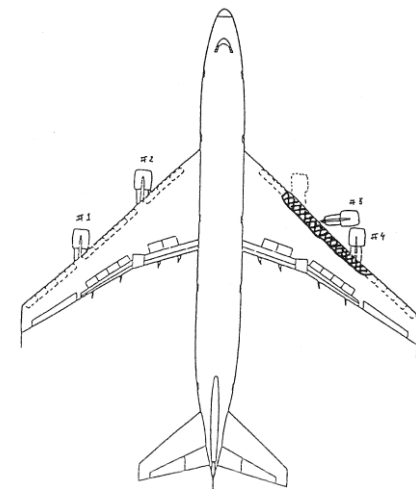
Estimated damage to RH wing leading edge

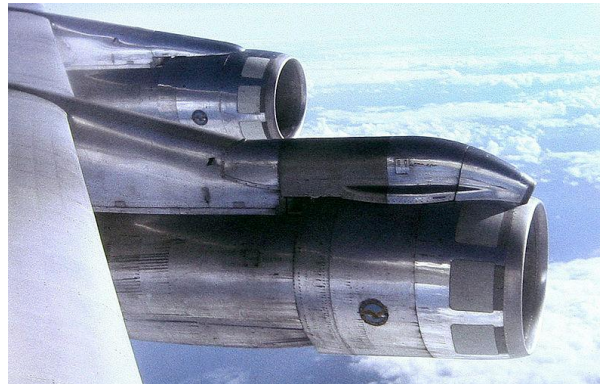
On April 25, 1992, Boeing 707-324C of Tampa, Colombia, left Miami Airport. Shortly after takeoff, engine number 3 and corresponding pylon separated from the airplane and struck number 4 engine nose cowling. Although number 4 engine inlet cowling and pylon skin damage, the airplane returned and landed without passengers or crew injuries.

Manufacturer and FAA inspection requirements for detection of cracks in midspar fitting were inadequate before the incident. The support fitting of engine number 3 pylon had been cracked due to fatigue. The crack resulted in the separation of engine number 3 and pylon.

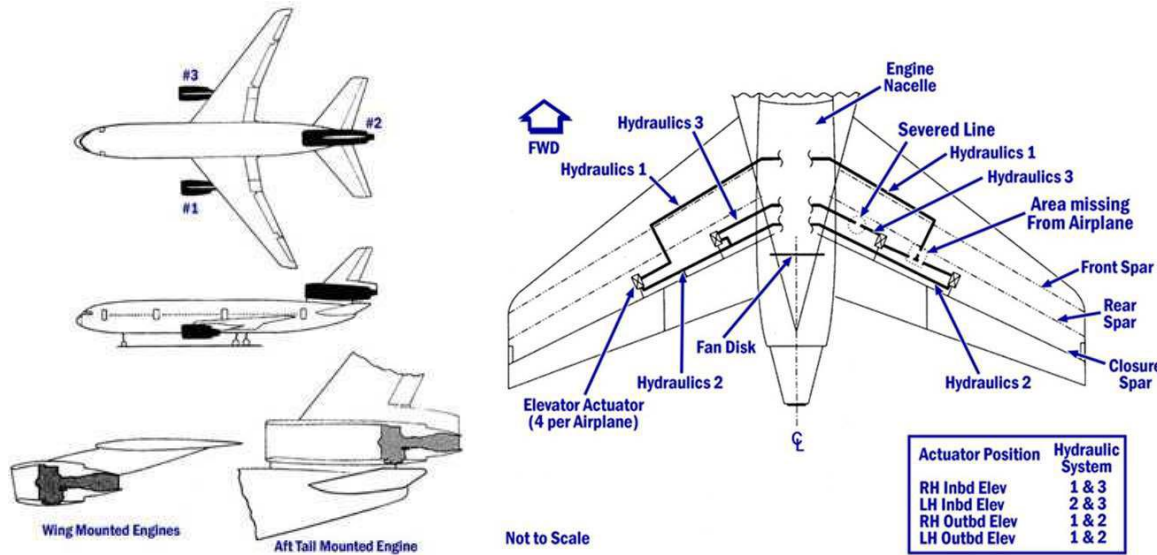
On July 19, 1989, United Airlines (UAL) Flight 232, a McDonnell Douglas DC-10-10, departed from Denver. During the flight, engine number 2 failed due to catastrophic uncontained fan disk burst. Engine debris damaged the aircraft's three hydraulic systems in the aircraft tail area. The flight crew could hardly control the aircraft with the use of asymmetric thrust control. The aircraft crashed while attempting to land.

Hydraulic systems and damage of the rear of the aircraft

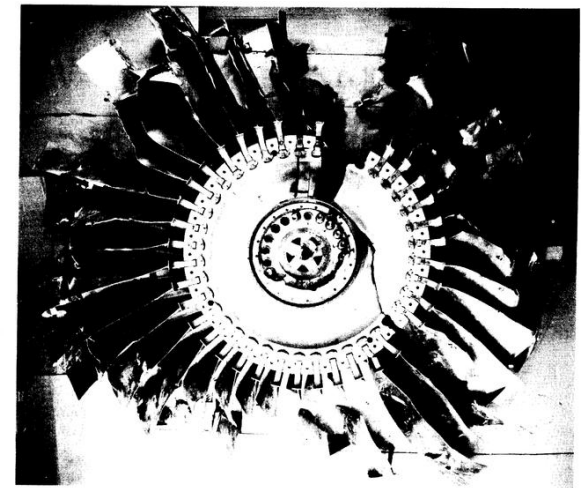
The recovered fan disk from the center engine

A metallurgical defect was formed during the initial manufacture of the titanium alloy material and was not detected by inspections during the manufacturing process. The defect caused the initiation of a fatigue crack located on the surface of the disk bore that eventually grew to a critical size and produced a catastrophic separation of the disk. The accident investigation determined that the fatigue crack was of sufficient size to be detected by the previous fluorescent penetrate inspections, if only they were properly performed.

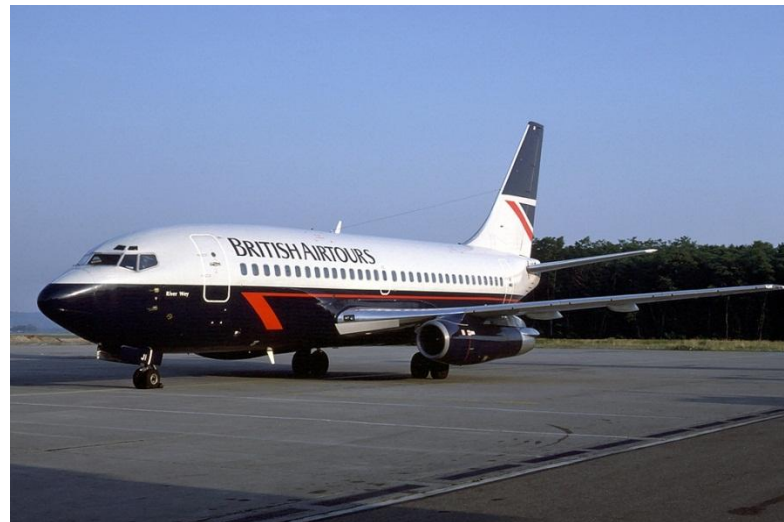
On August 22, 1985, Boeing 737-200 of British Airtours, departed from Manchester International Airport, UK. During takeoff, the left engine experienced a failure. The flight crew decided to abort takeoff and found fire in the left wing. Fuel leaking from the wing ignited and burned. The aircraft was burned severely. The crew organized evacuation through the right-hand side of the airplane. Fifty-five lives were lost, others survived through successfully escaping.

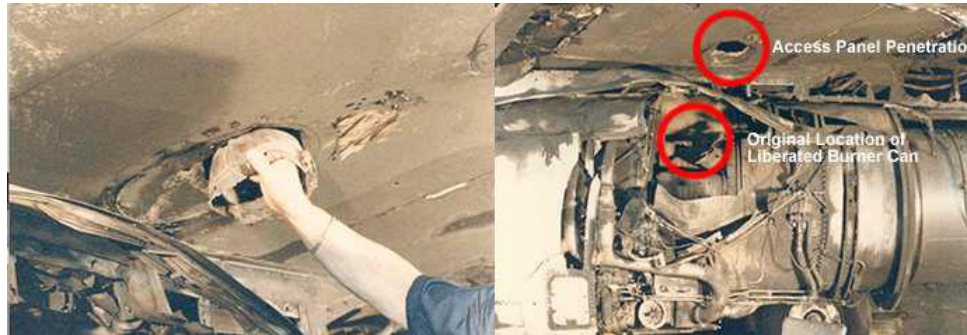
There was an uncontained failure in the left engine. A section of the repaired combustor can, which remained in service beyond its fatigue life, was ejected from the engine and fractured an under-wing fuel-tank access panel. The panel was insufficiently constructed to withstand the impact from the failed engine pieces. Thus, fuel leaked from the wing, ignited and burned.
