# Thermomechanical Fatigue, Sulfidation and High Cycle Fatigue of JT3D Engine Turbine Blade

Maj. Inna Kaparovsky IAF-FAI

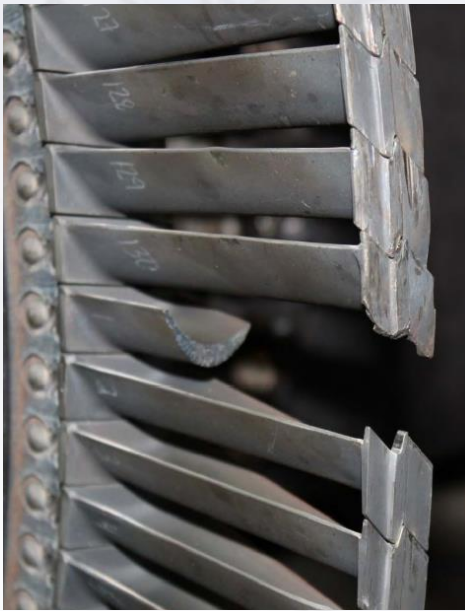
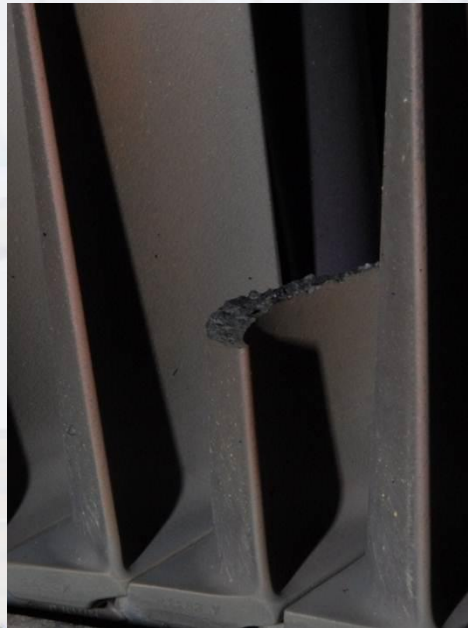
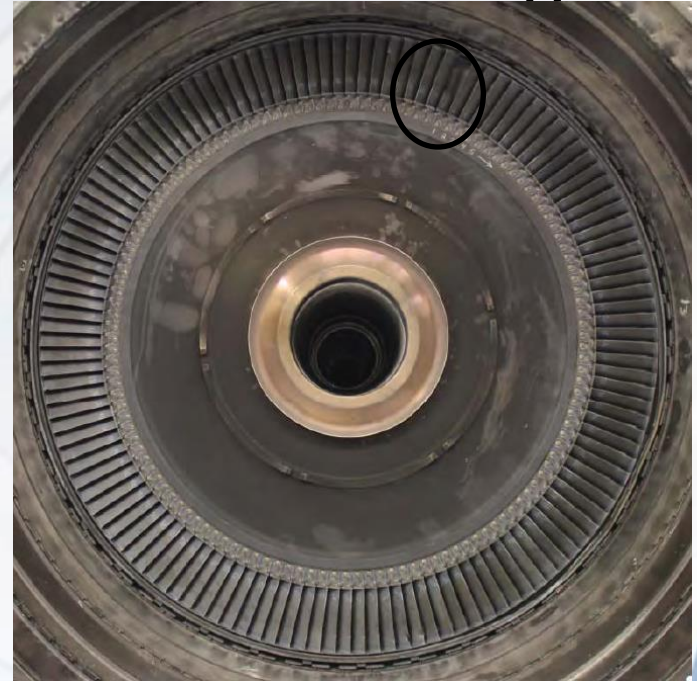
- Single fractured High Pressure Turbine Stage 1 Blade (~1/3 blade height)

- The cause for the engine failure was the fracture of a single High Pressure Turbine Stage 1 blade.
- The blade fracture was due to High Cycle Fatigue propagating from an initial crack
- The initial crack is a Thermal Mechanical Fatigue crack originating at the lead edge at approximately 30% span
  - The TMF was accompanied by Oxidation and Sulfidation process

- limit blade service life to three service intervals (first run and two strip and recoats)

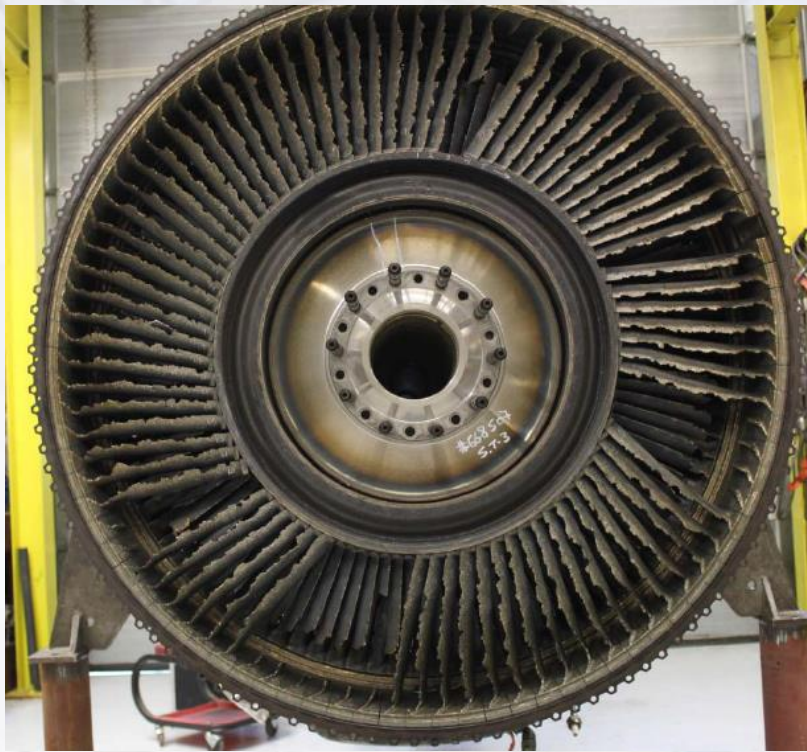
Stage 4

- Low Pressure Turbine airfoil damage

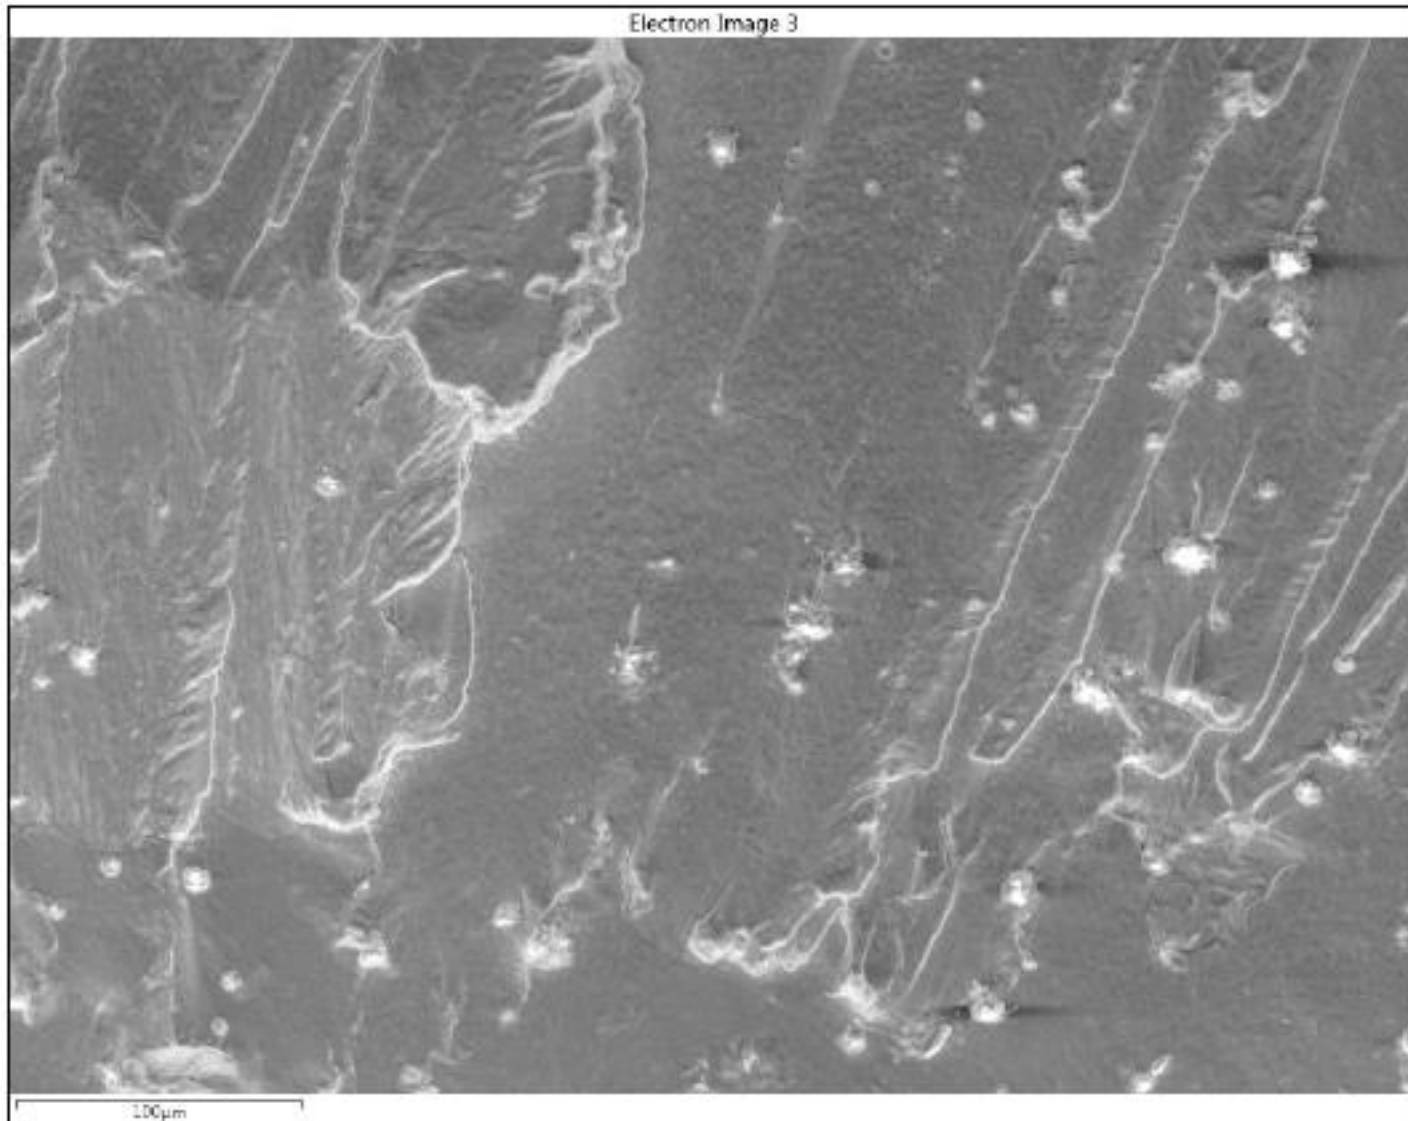
# Fracture Surface - HCF

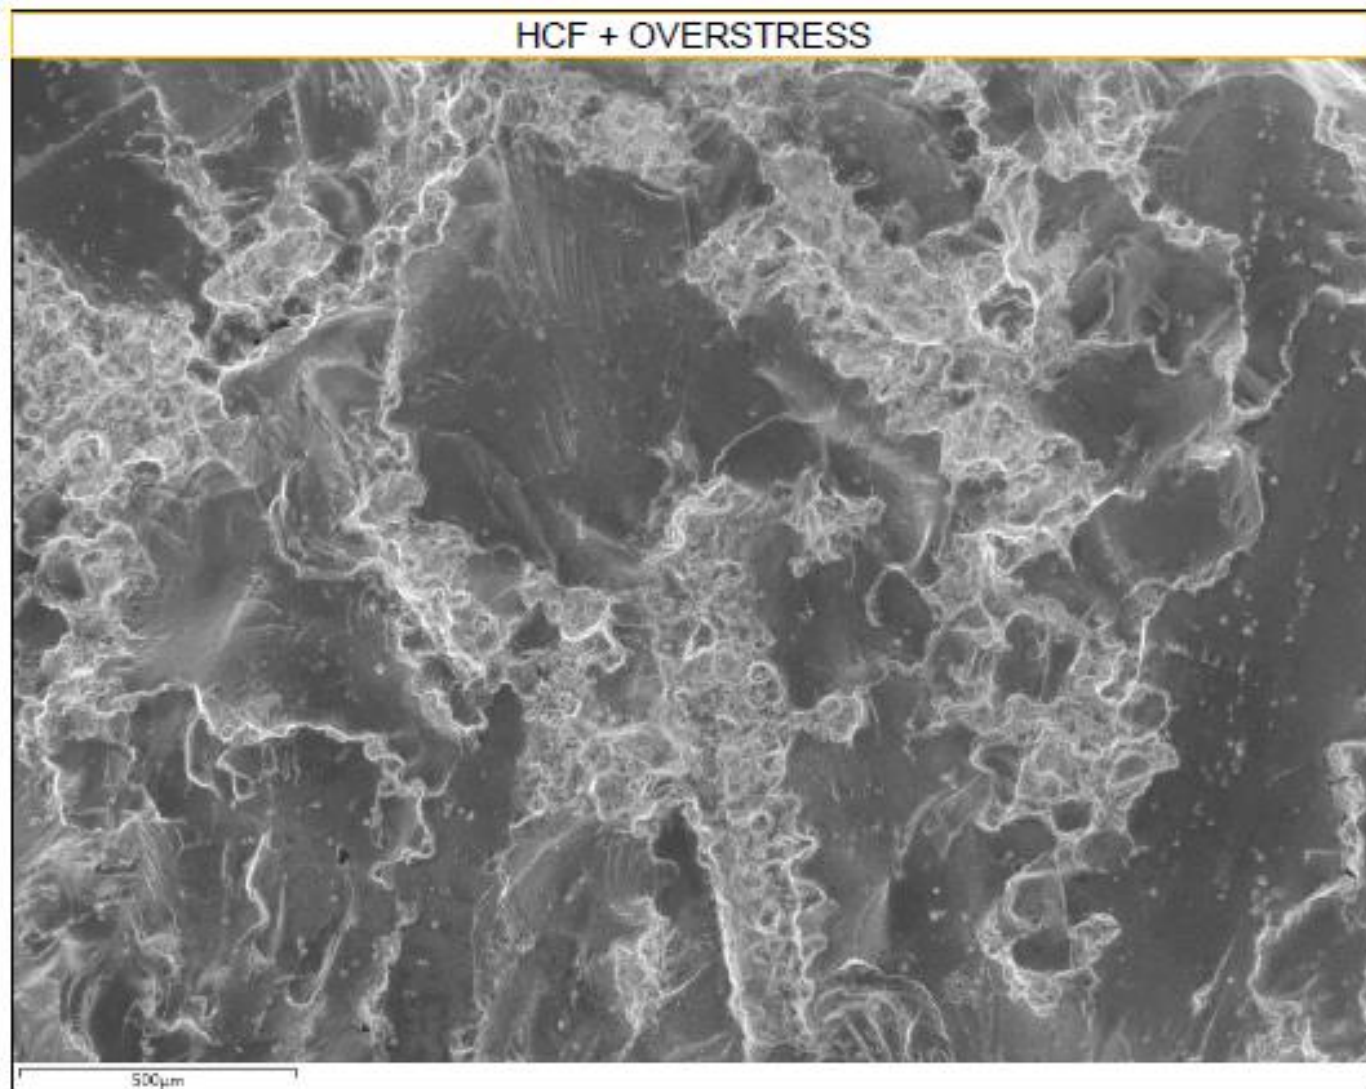
# Fracture Surface - Mixed HCF & Overload

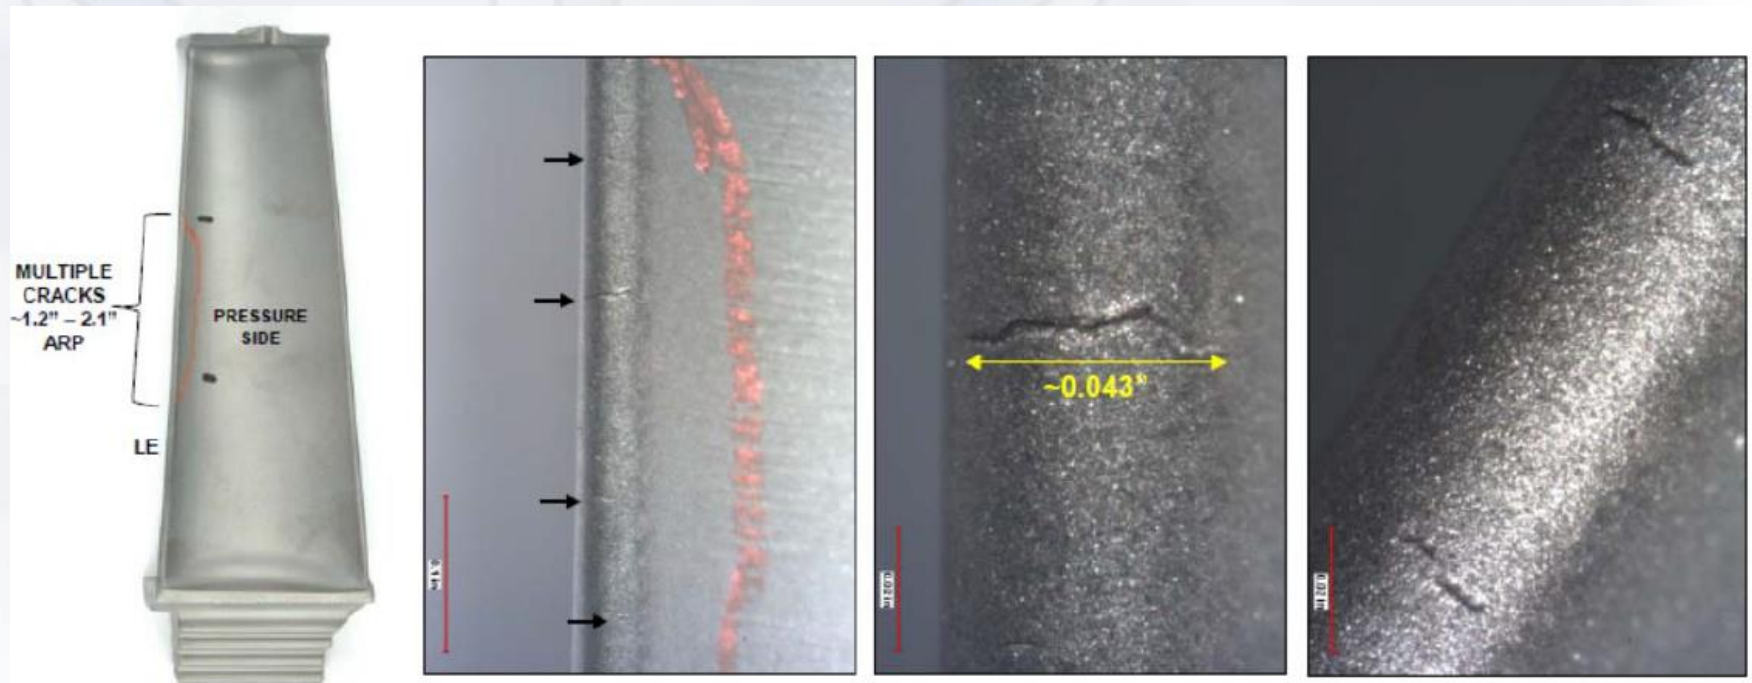
- 10 additional blades with cracks

- All 10 blades have similar markings:  
no evidence of the coating on the fracture surface at the origin area to indicate that a crack had been present during the last strip and recoat cycle

- TMF cracking was found at similar locations on 10 other blades with similar markings suggests a shared service
- There were no material, manufacturing, service or overhaul factors that were identified as probable contributors to the blade fracture
- The most probable cause for the TMF crack is the blade material having exceeded its useful TMF life

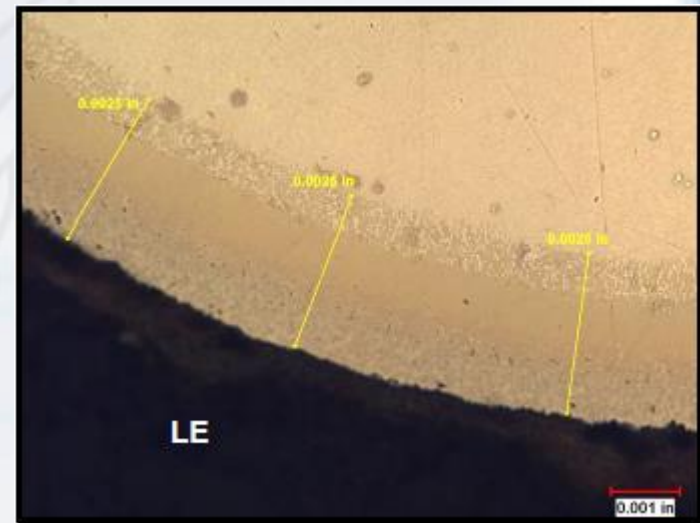
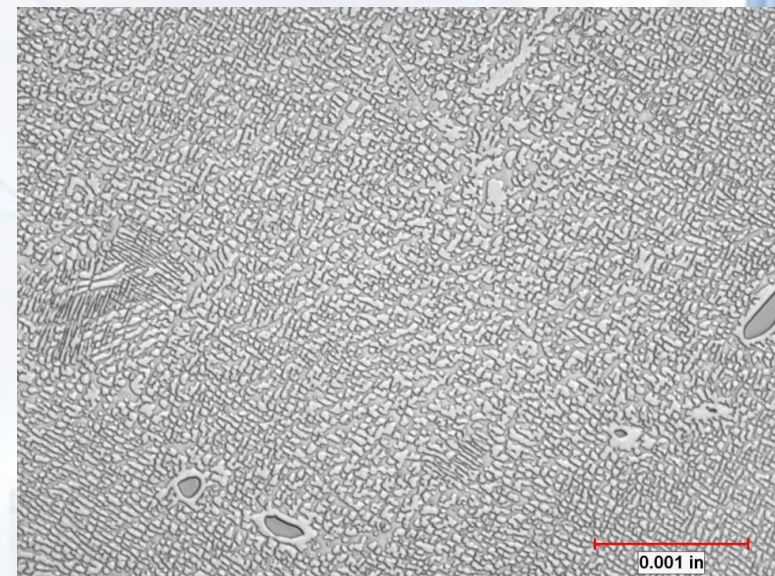
- The coating exhibited a uniform typical three-zone microstructure
- Bulk microstructure appeared typical with no evidence of temperatures 2000°F or above

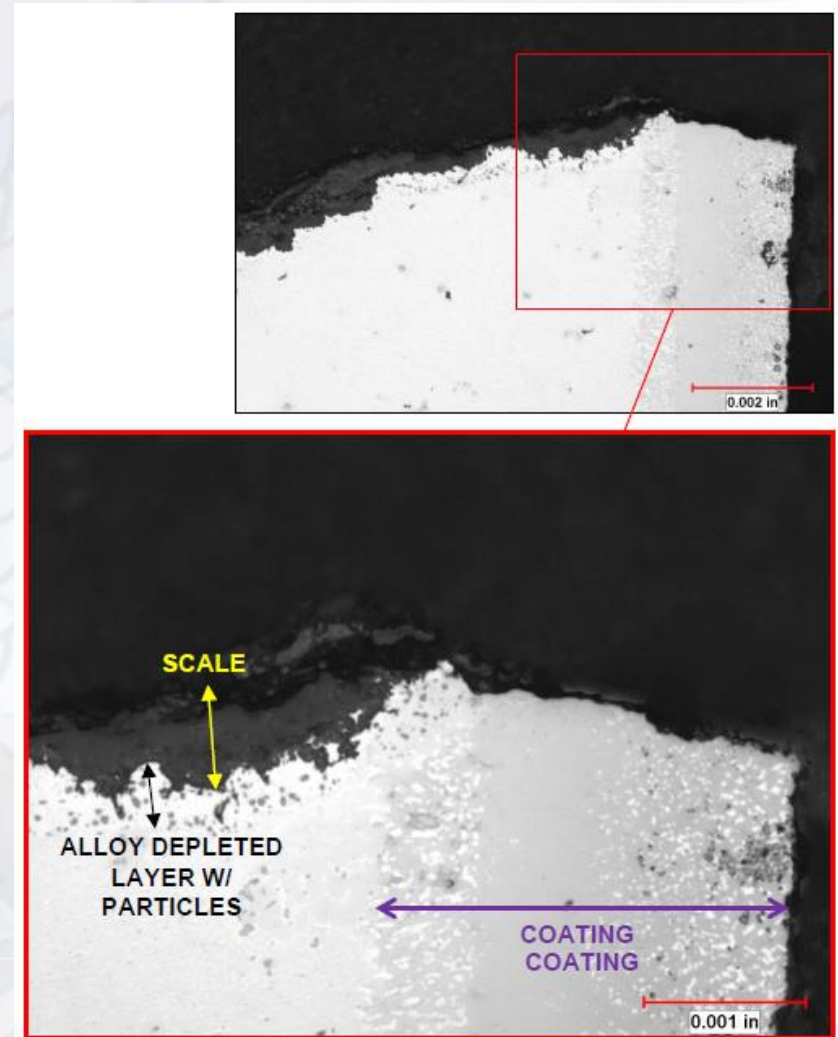
- Oxidation on fracture surface
- Alloy depleted layer along the fracture surface indicative of Sulfidation
