Performance Monitoring of IEC Industrial Gas Turbines

**For presentation to 13th Israeli Symposium
on Jet Engines and Gas Turbines
November 06, 2014. Haifa, Israel**

**IEC Generation Division Headquarters
Mechanical Department**

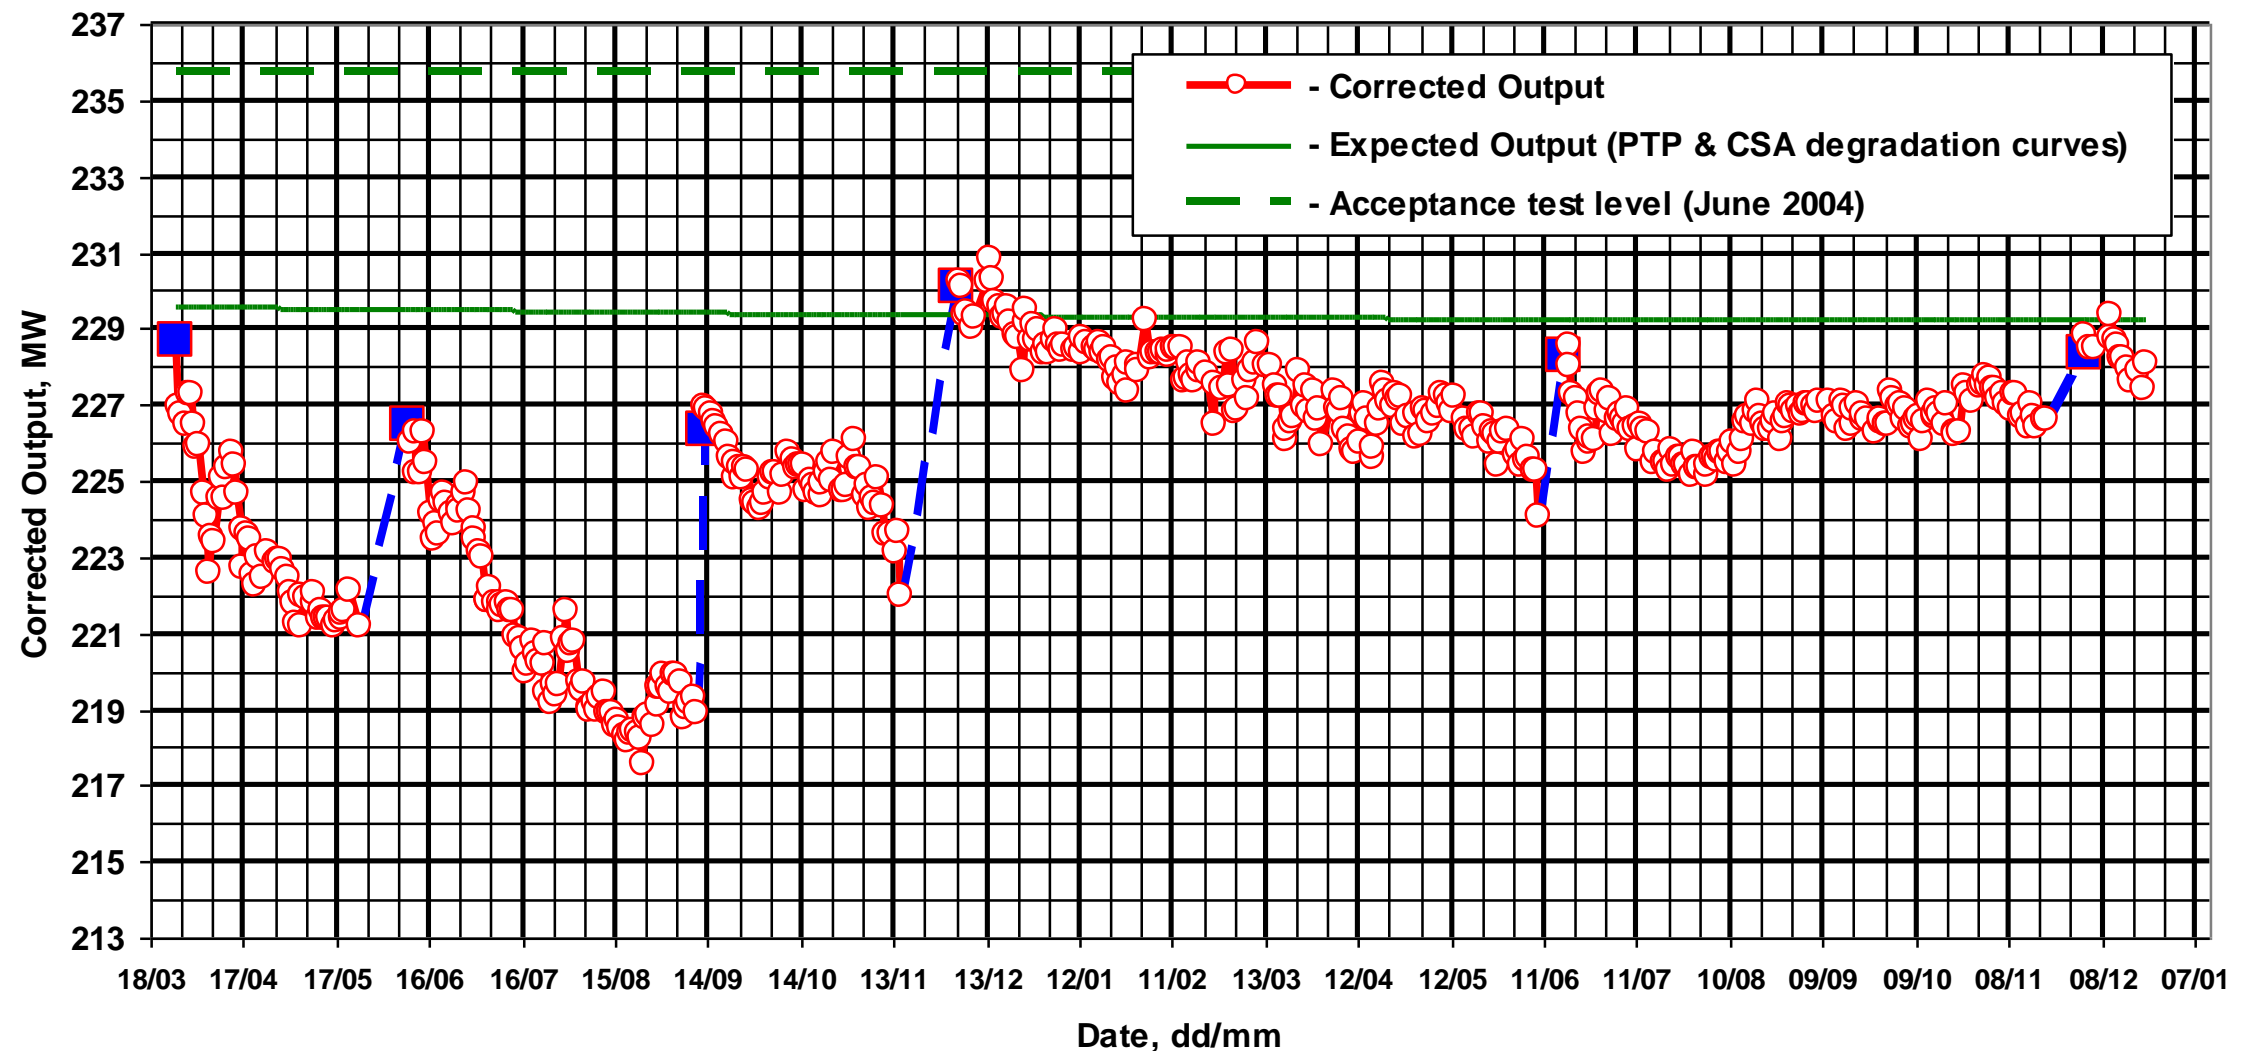
Trend of corrected power output

Eshkol EM-1. Gas Turbine Operation.

Test data from 26/03/10 until 22/12/11.

Blue dashed lines denote compressor washings

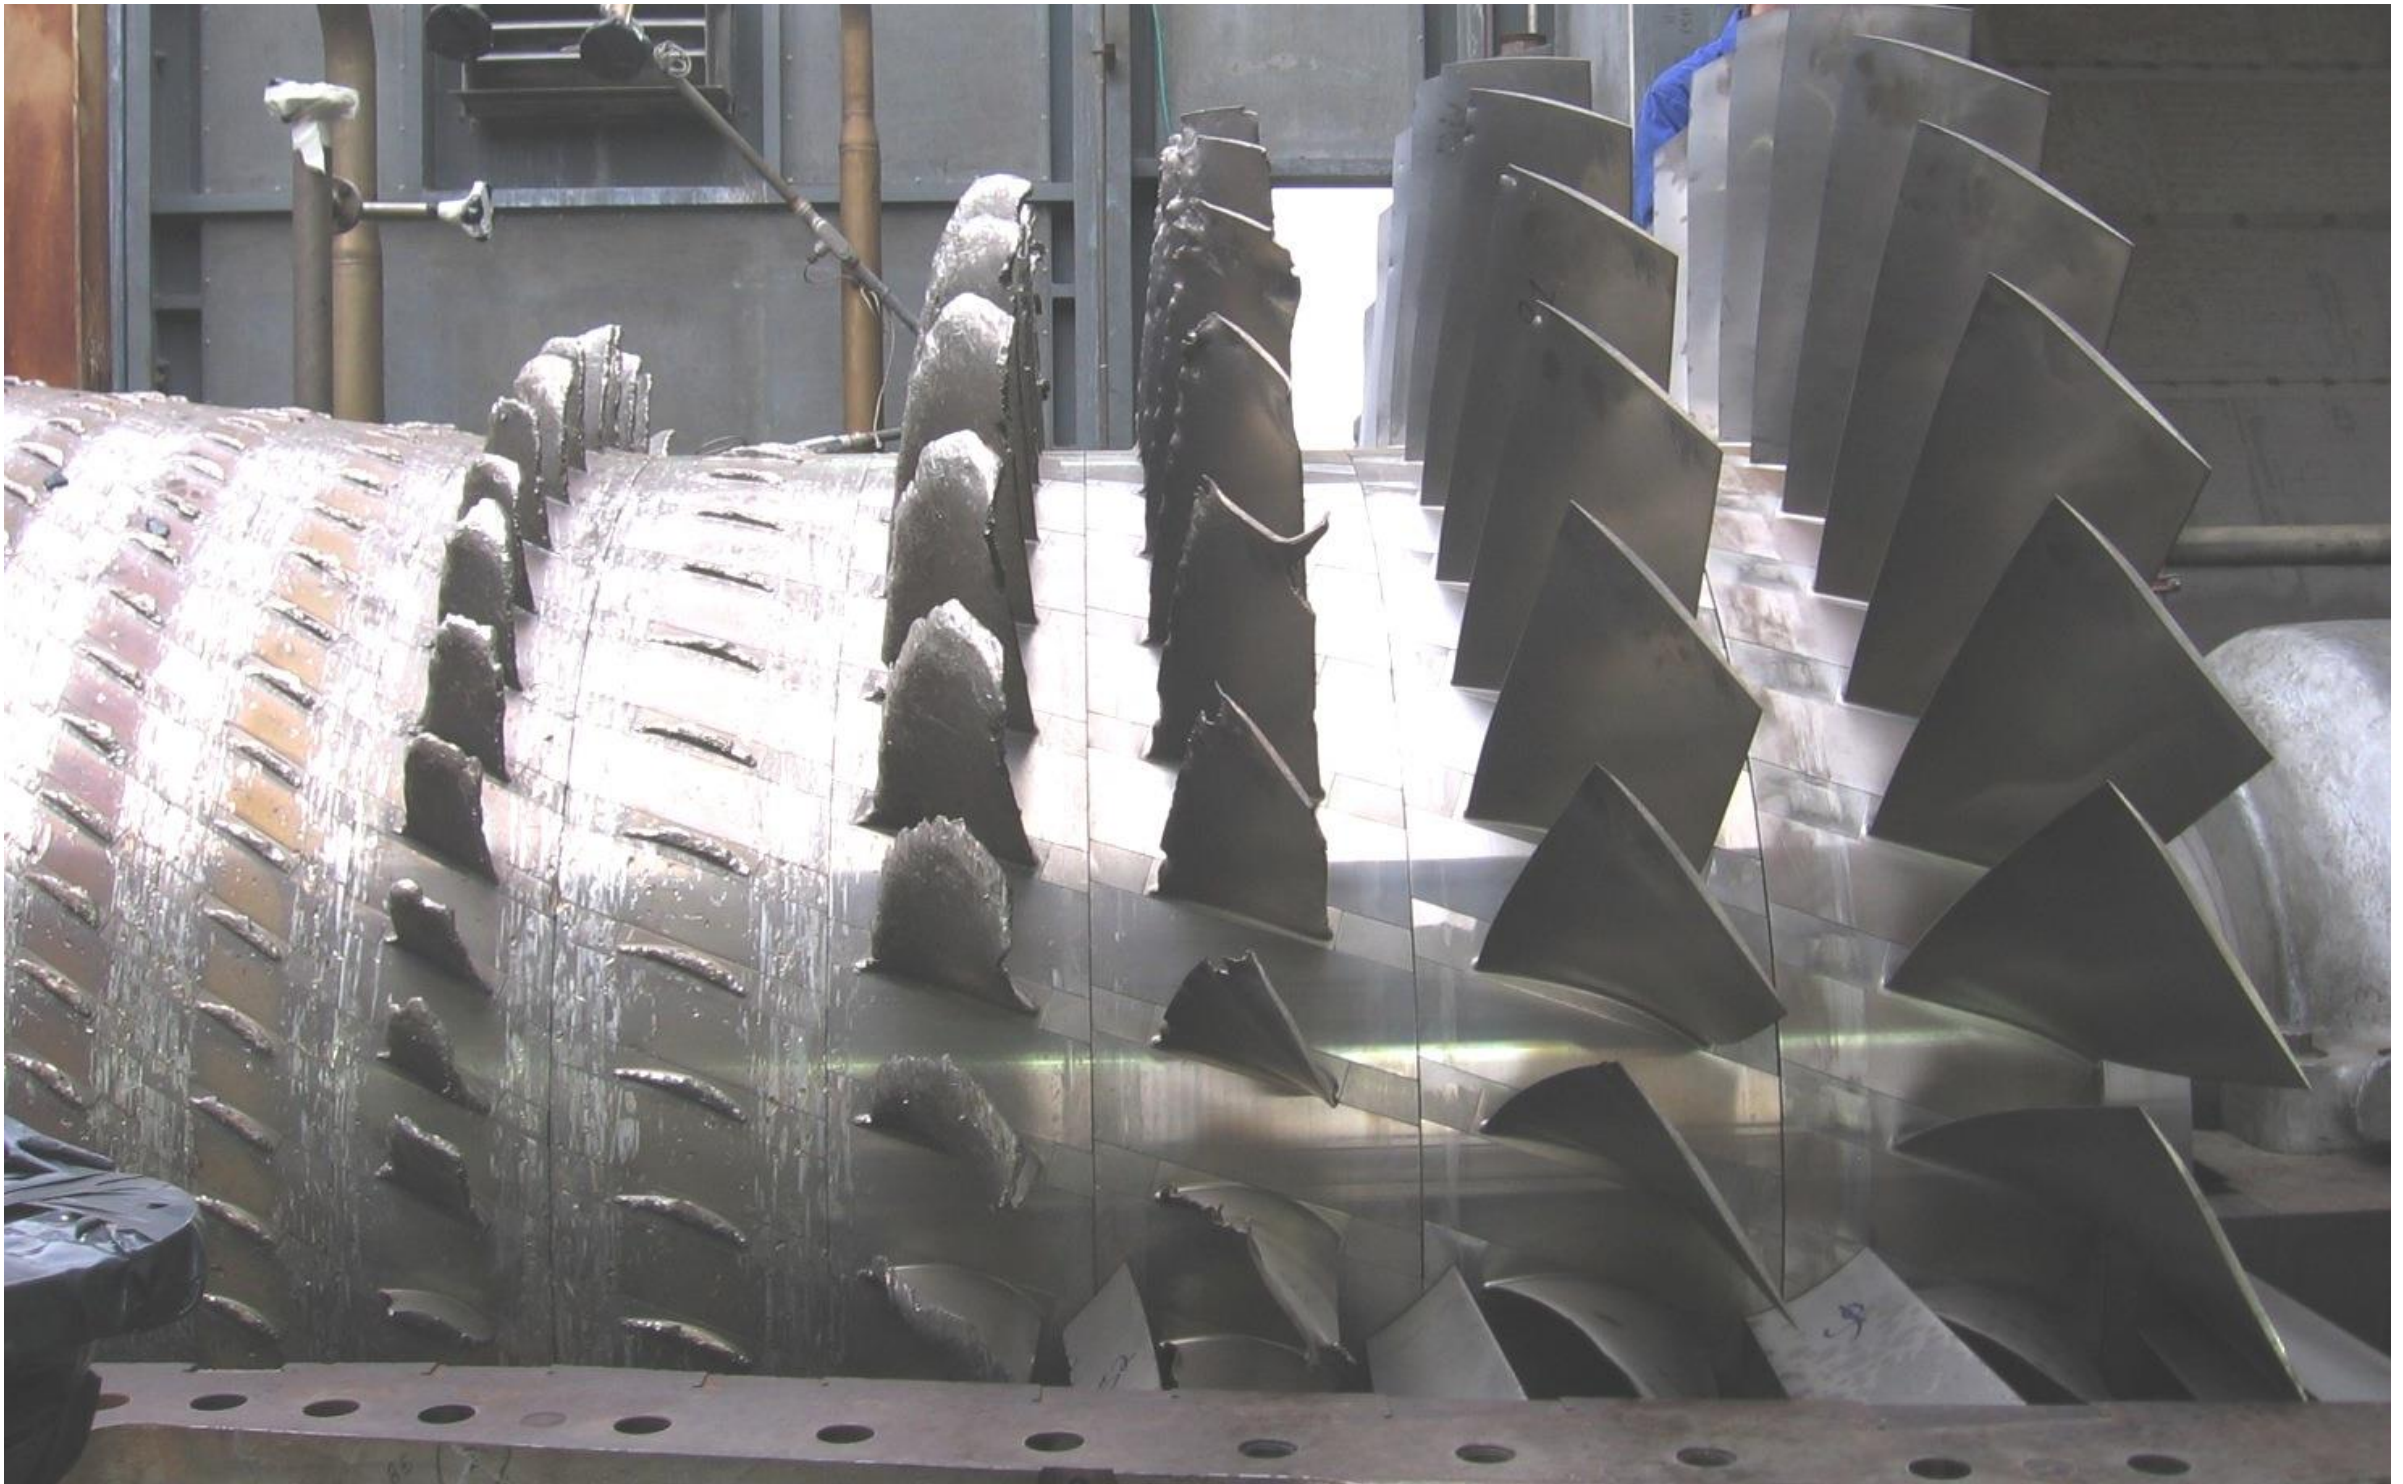
Nevertheless, the catastrophic failure occurred in field (next slide).

Case Study 1. Compressor Failure: Rotor after failure

Catastrophic failure of the compressor was a result of unfortunate combination of technical and organizational drawbacks.

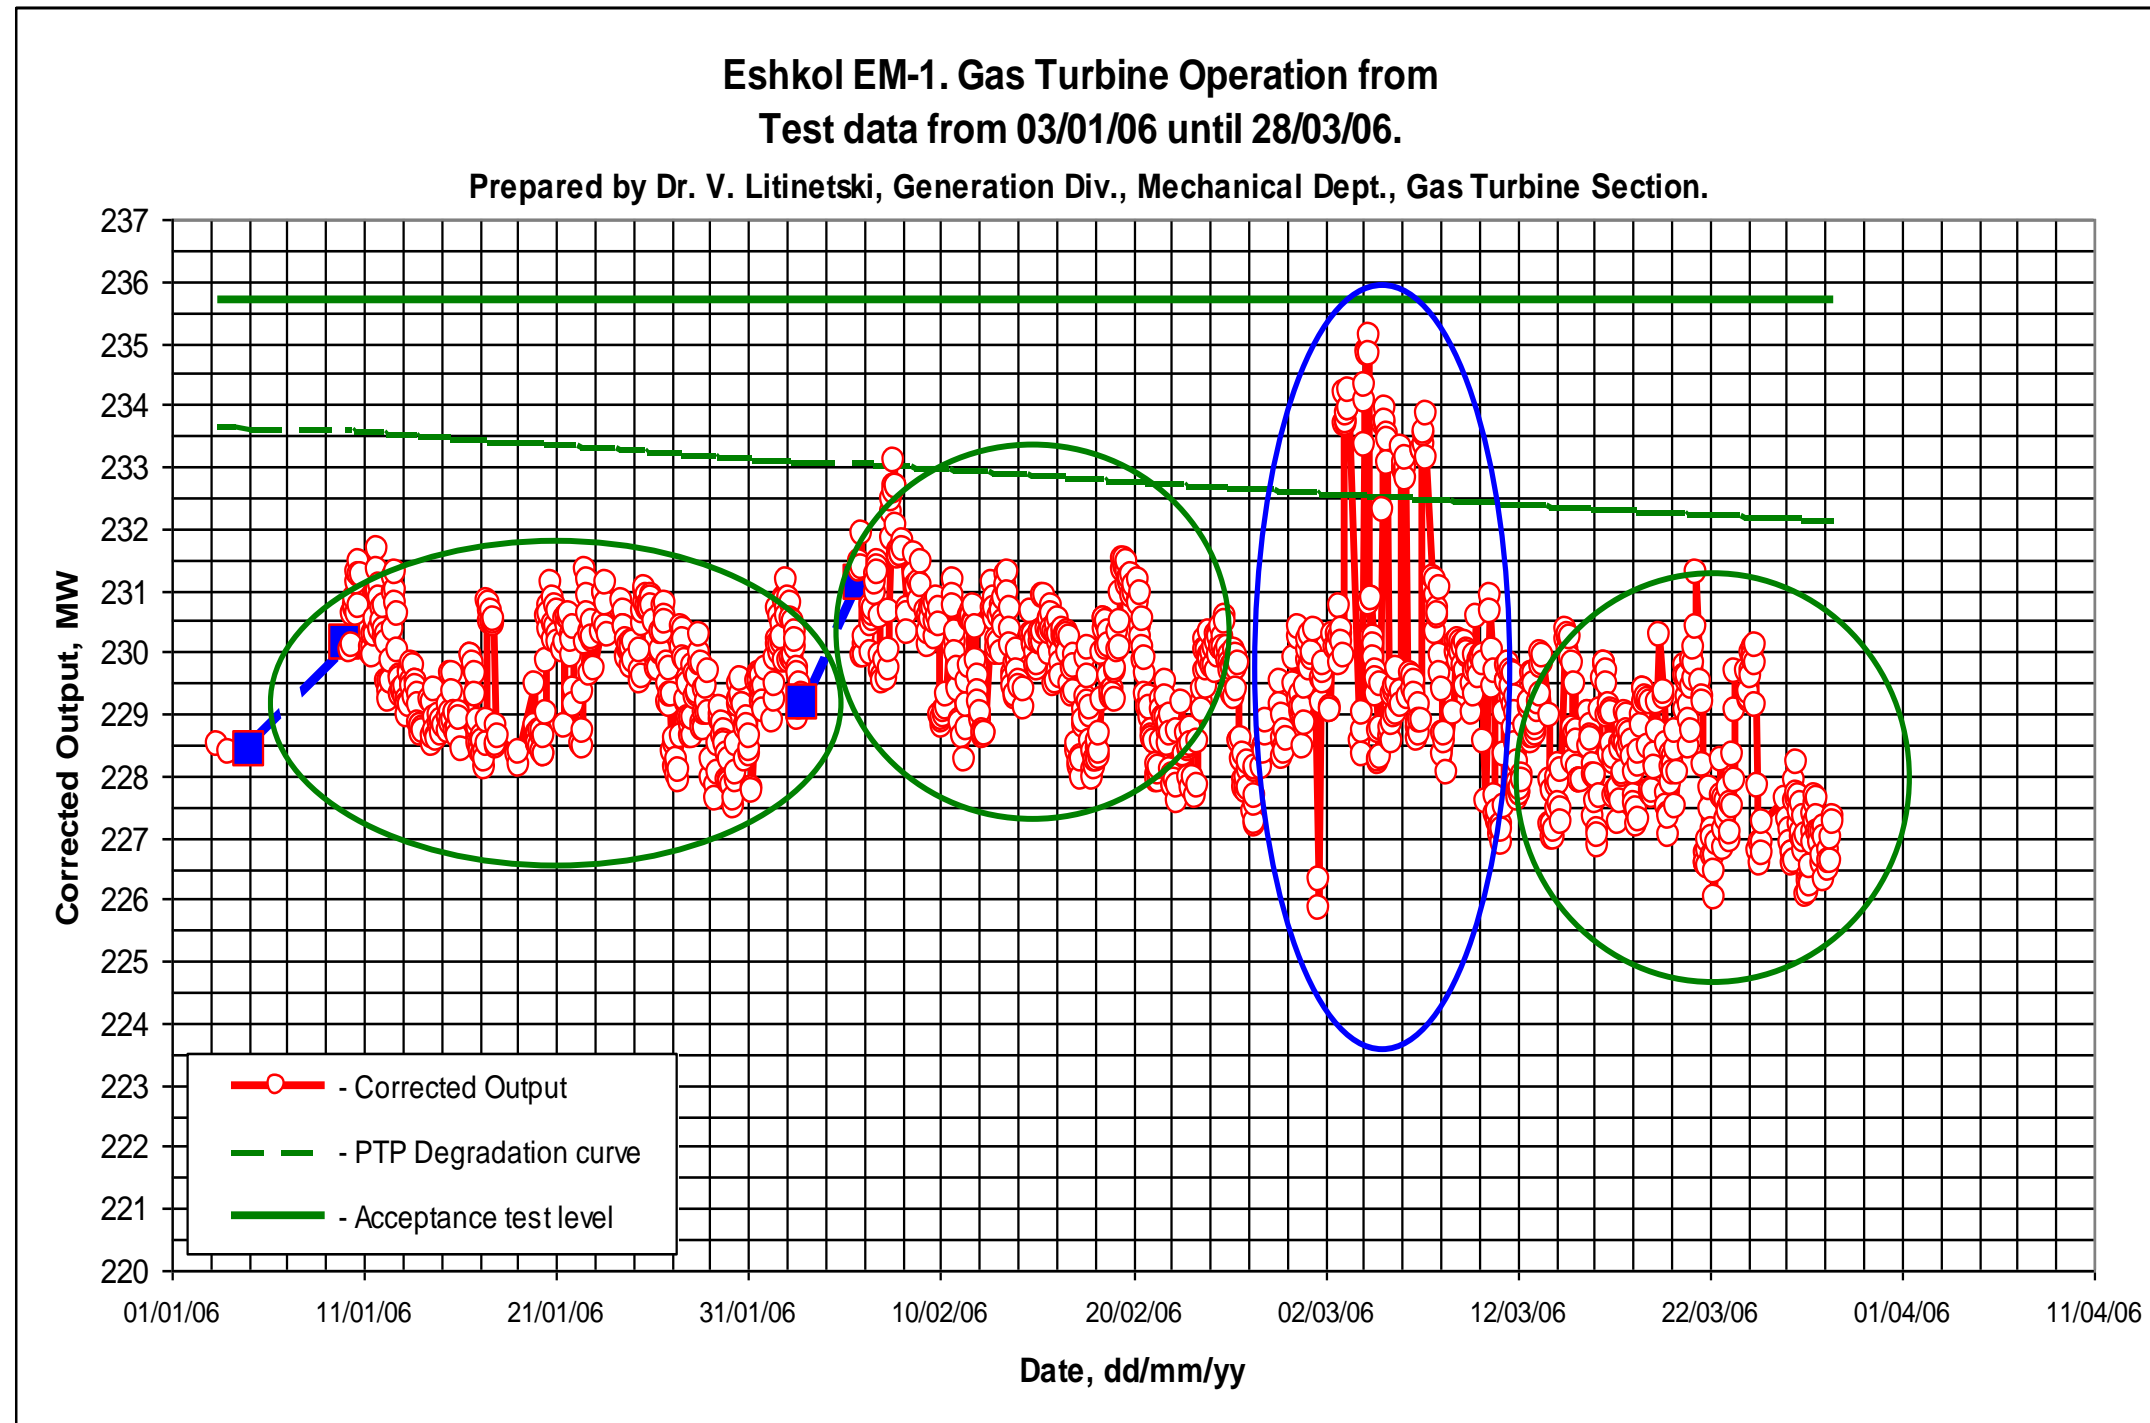
Irregular increases of the power output by 10-15 MW above the expected maximum were detected in about two months after the upgrade (Figure below).

The event continued during a week and after that disappeared.

Case Study 2. Power output scattering

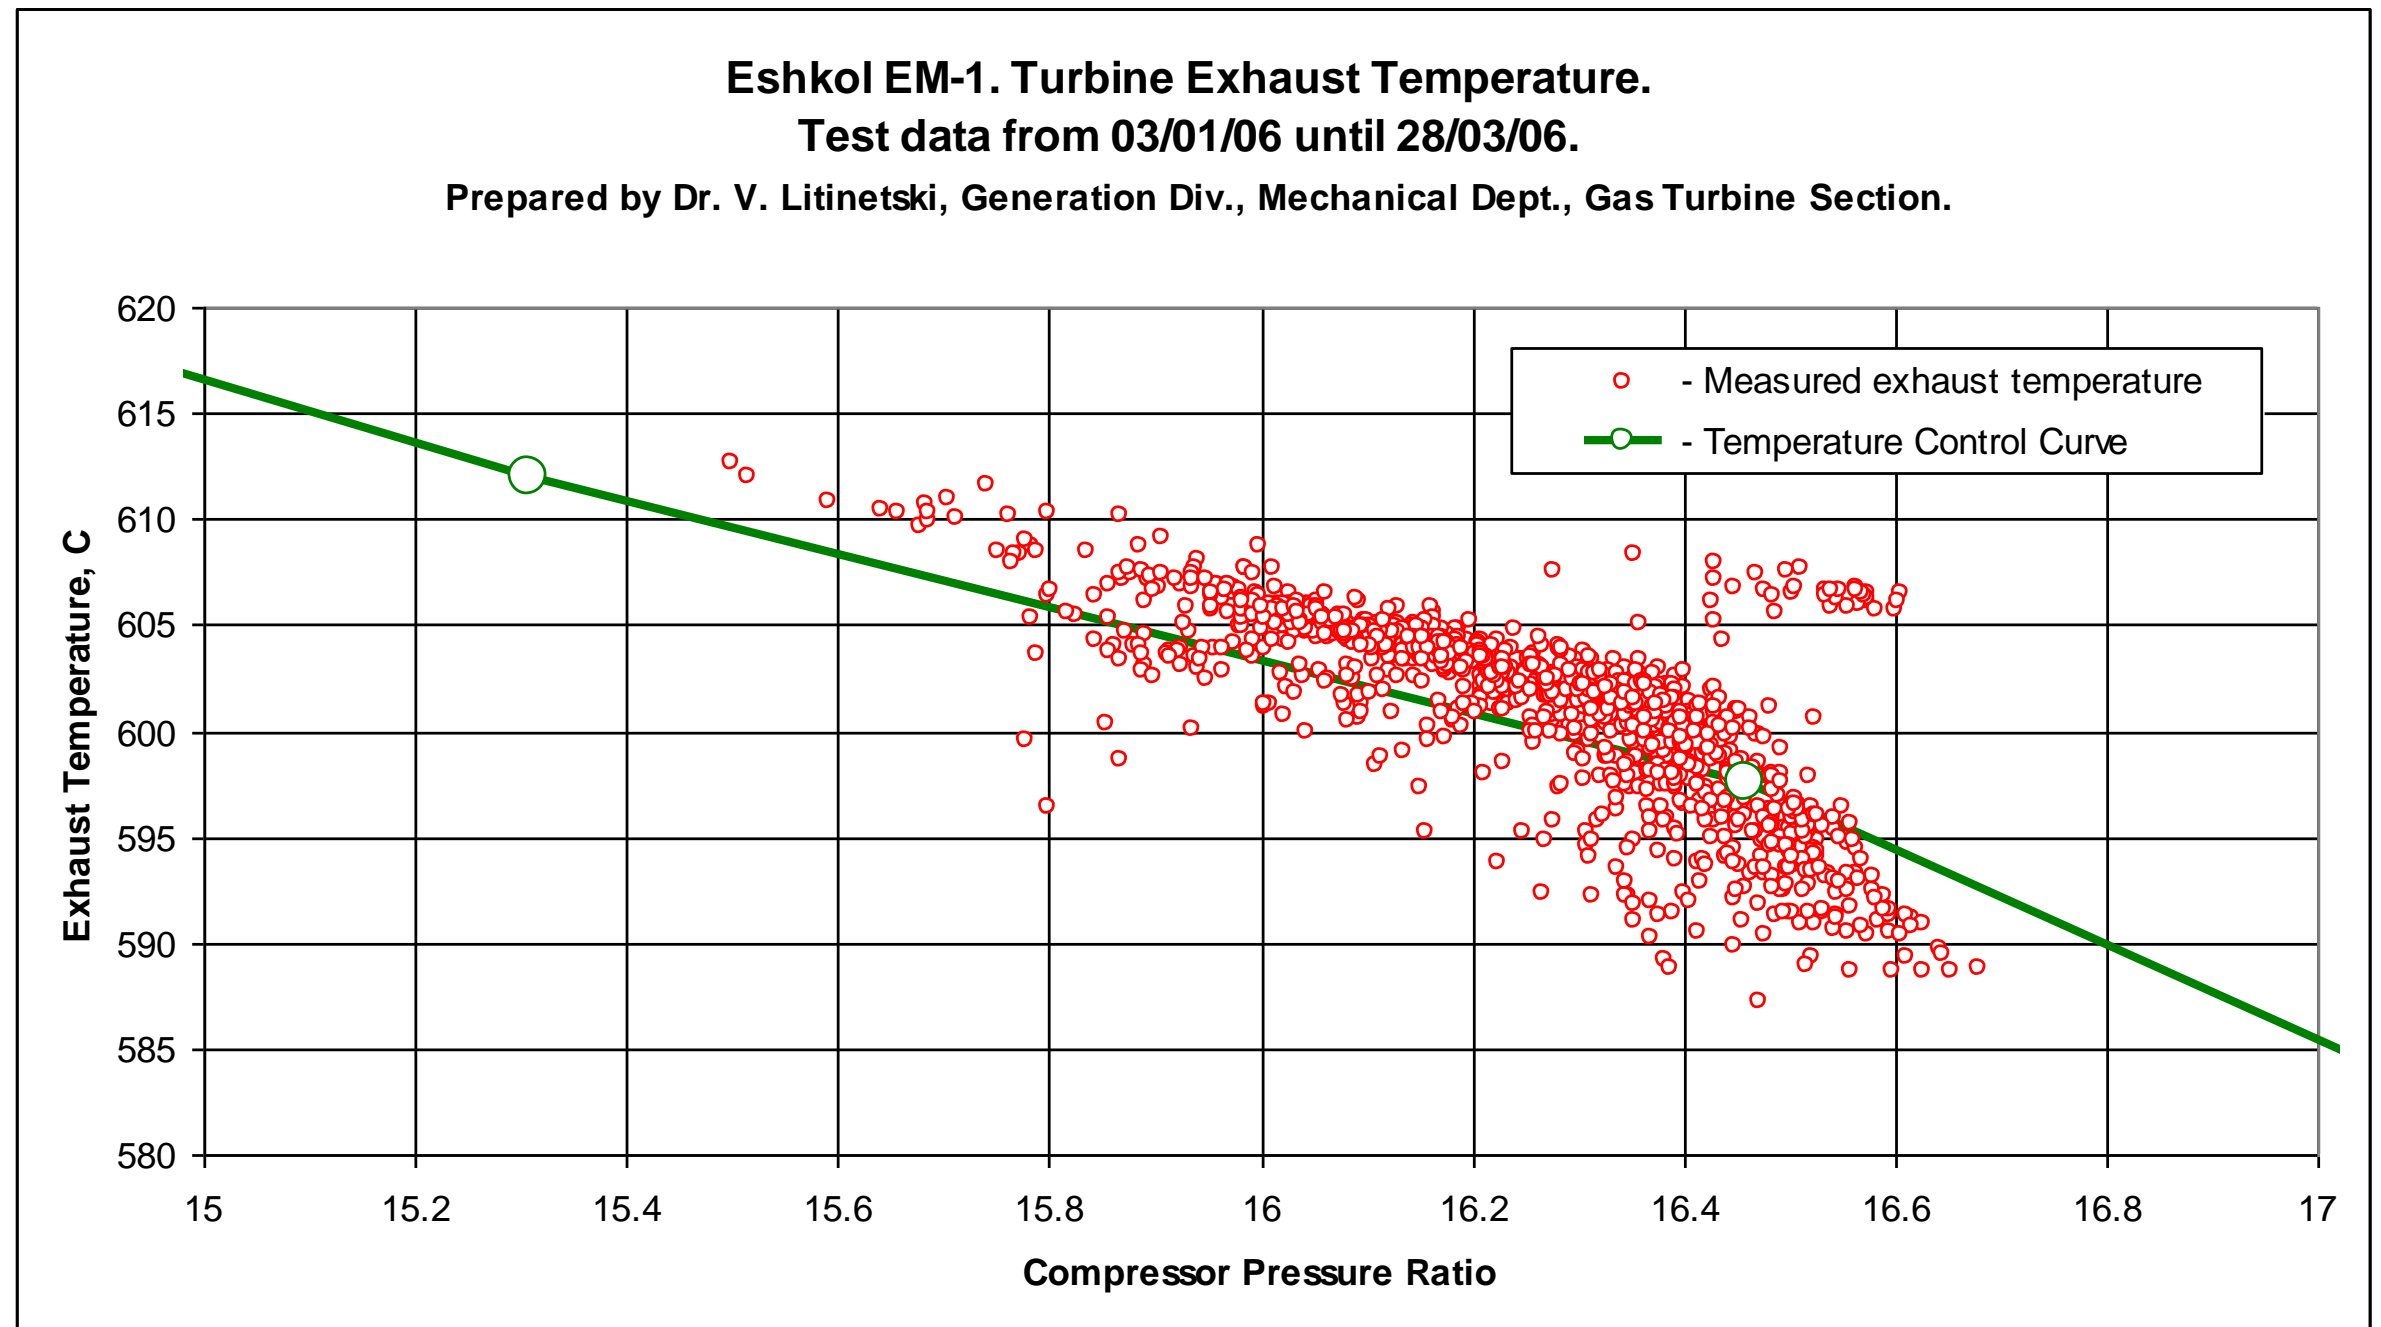
Performance monitoring data showed that the irregular increases of power output were accompanied by significant scattering of the turbine exhaust temperature (Figure below)

Case Study 2. Scattering of exhaust temperature

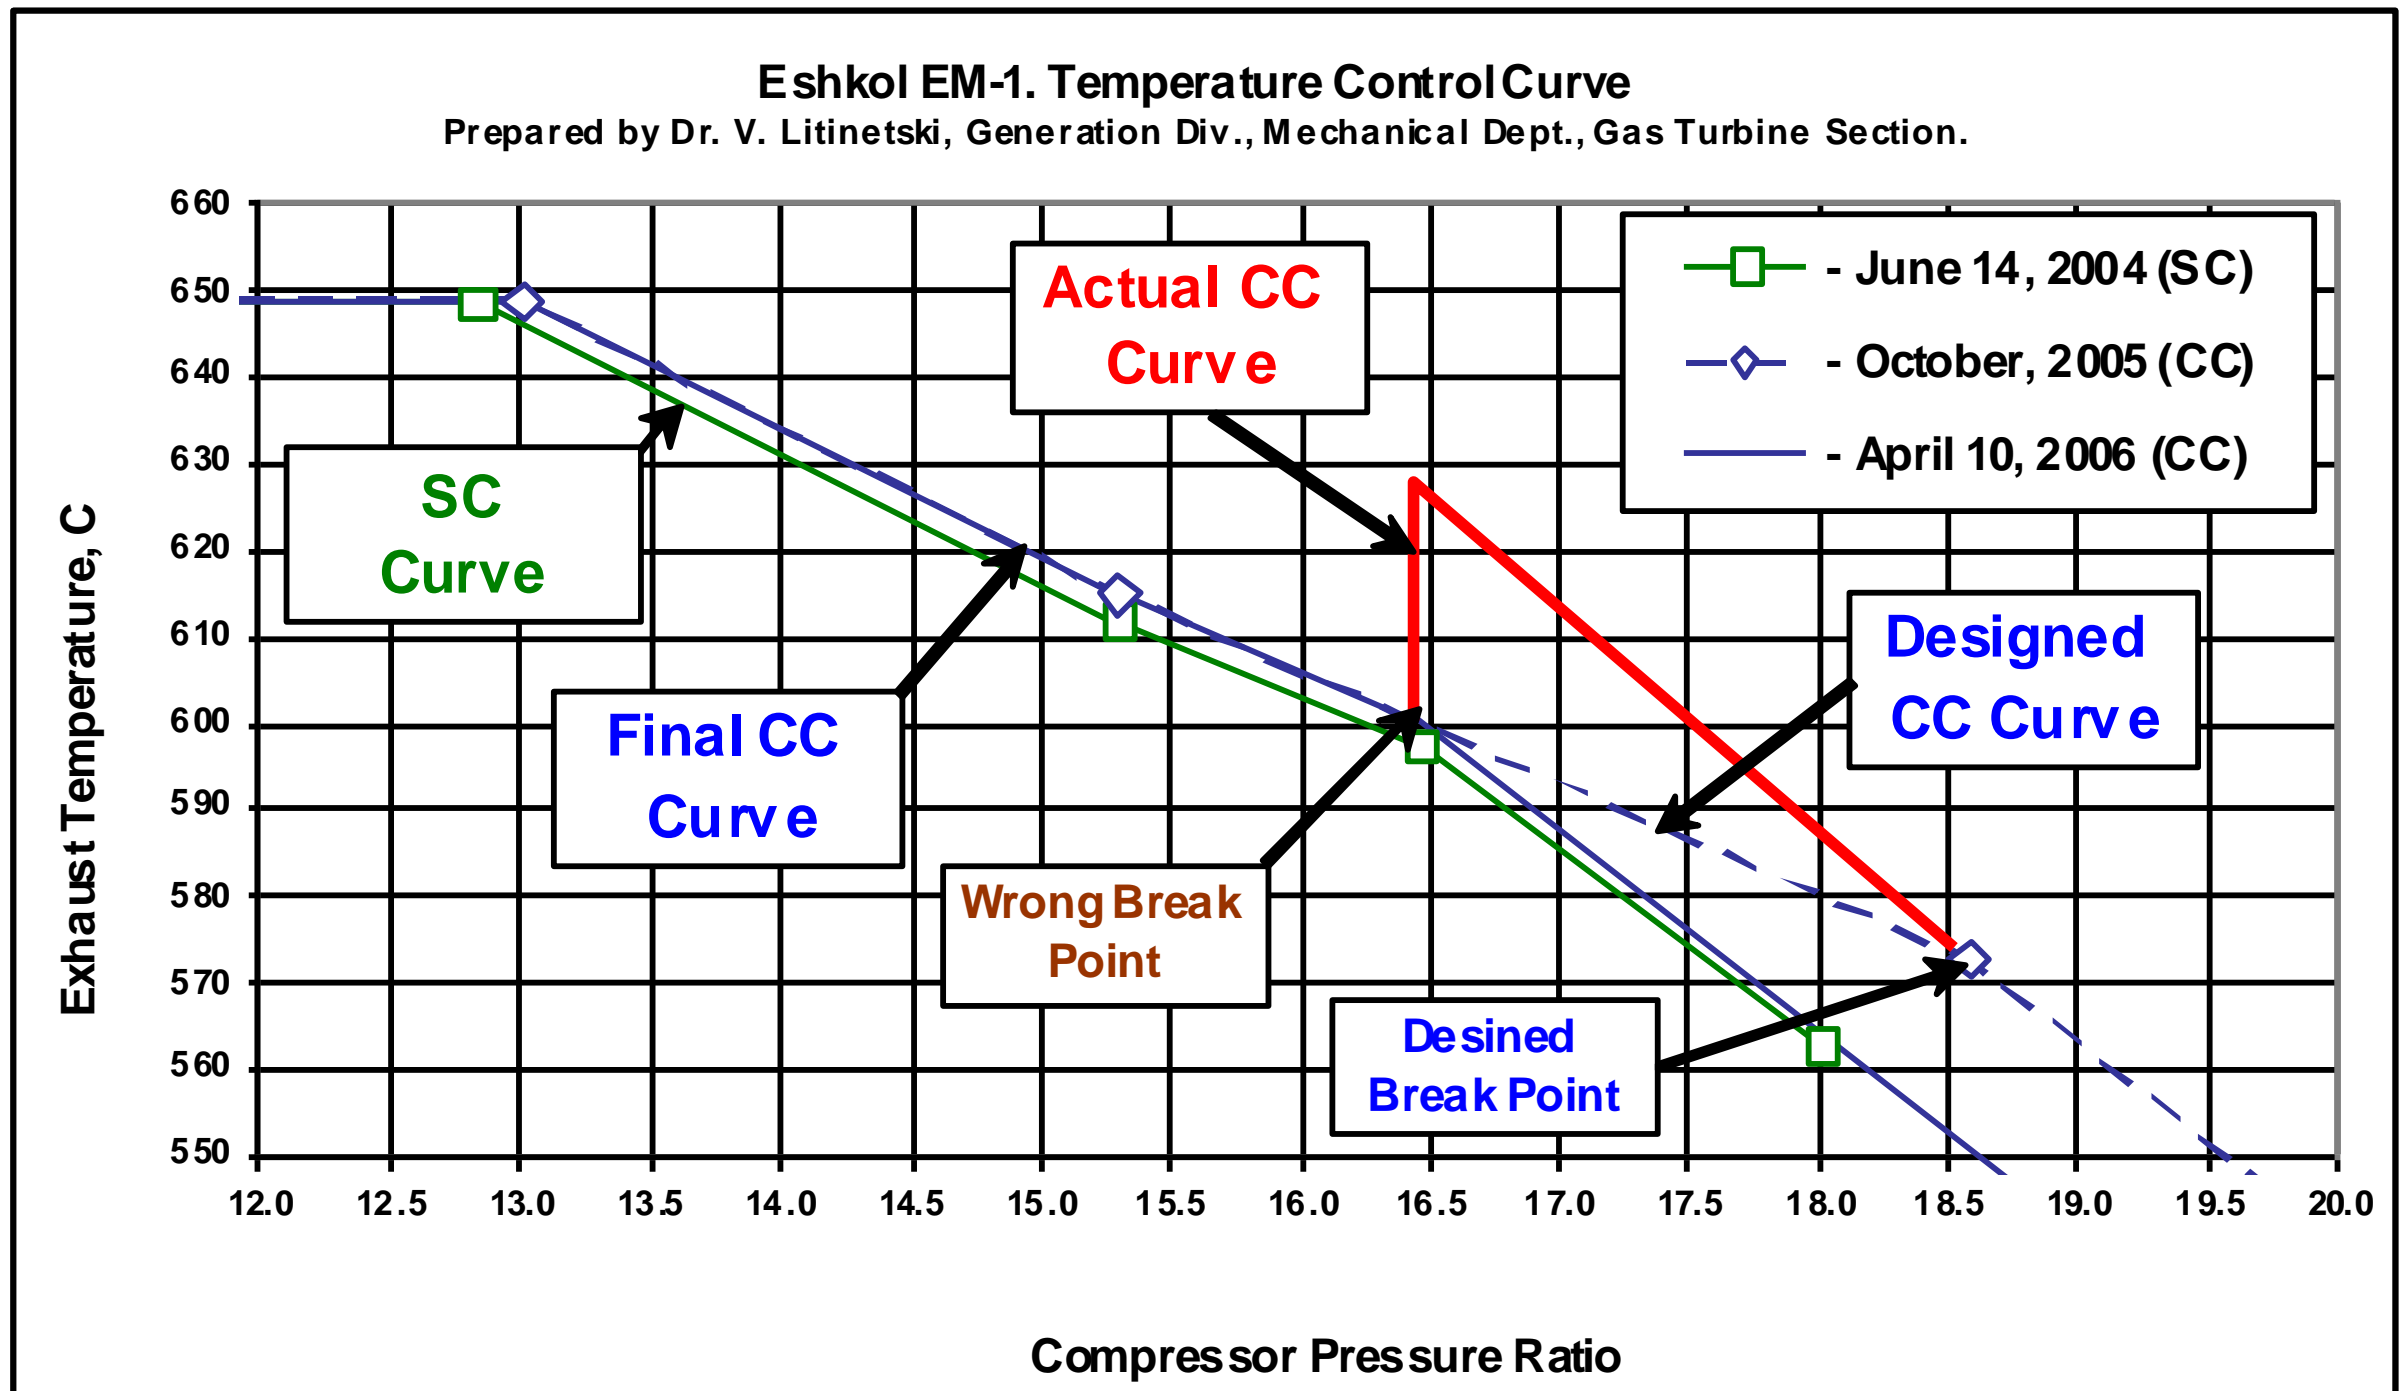
Thorough analysis of the data revealed an error in the control system software, namely, an incorrect definition of so called **Temperature Control Curve, which is an important element of the turbine load control, fuel efficiency and protection (Figure below).**

Case Study 2. Error in control system software

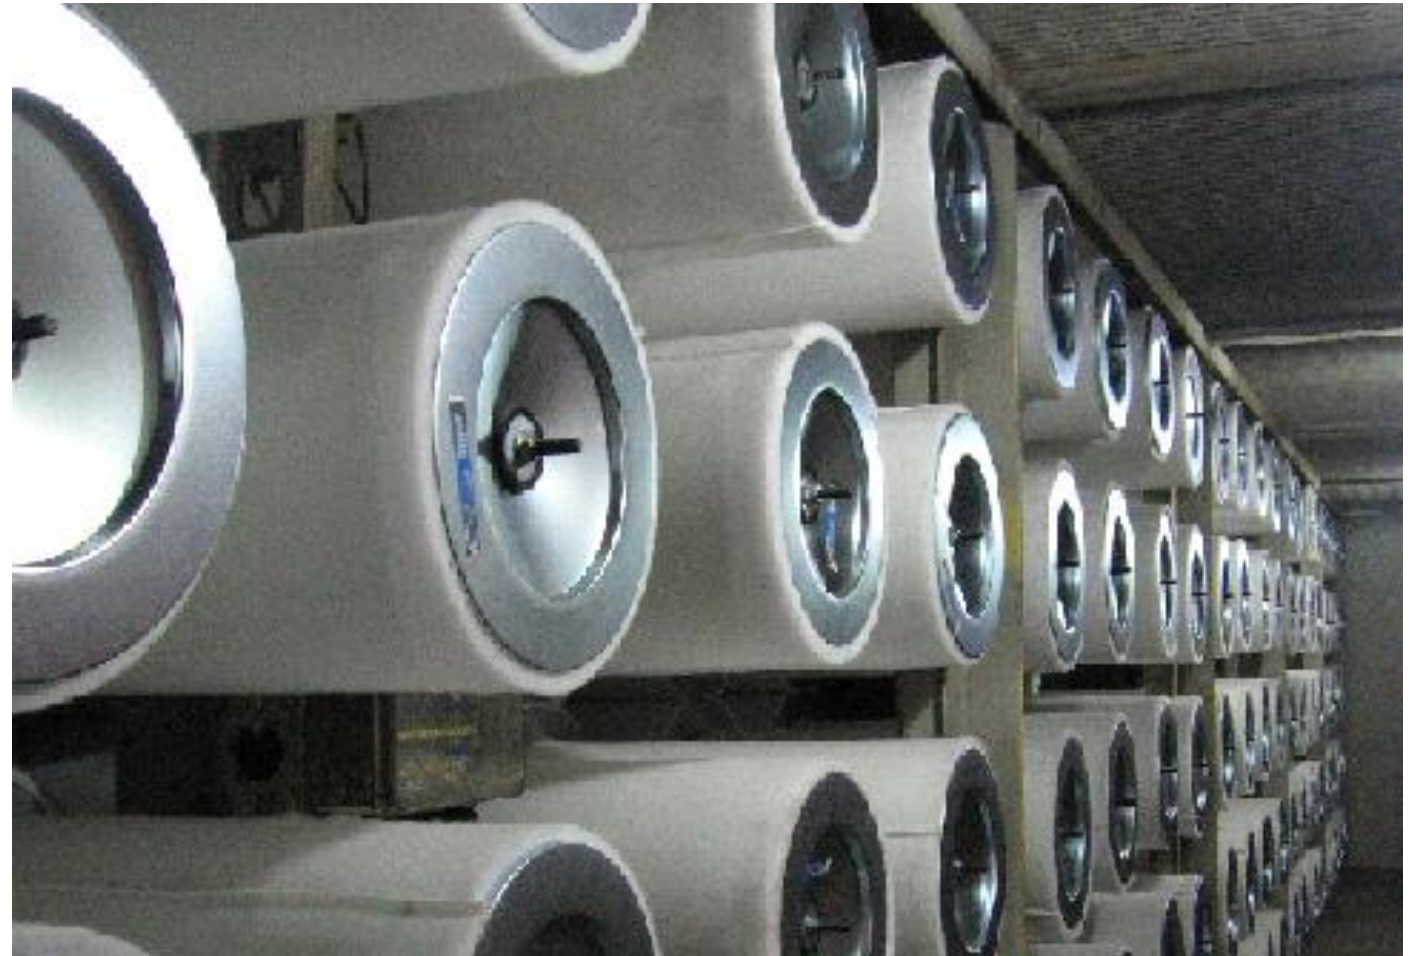
Case Study 4. View of the installed filter

Three-layer compact design EPA cartridges

The filter met expectations of the project team. It obviously provided much better air filtration that led to substantial improvement of GT performance.
