**The 11th Israeli Symposium on
Jet Engines and Gas Turbines (25 October, 2012)**

CONTINUED AIRWORTHINESS OF AIRFRAME / ENGINE INTERFACES

Based on study performed in
Cranfield University, England

Israel Aerospace Industries

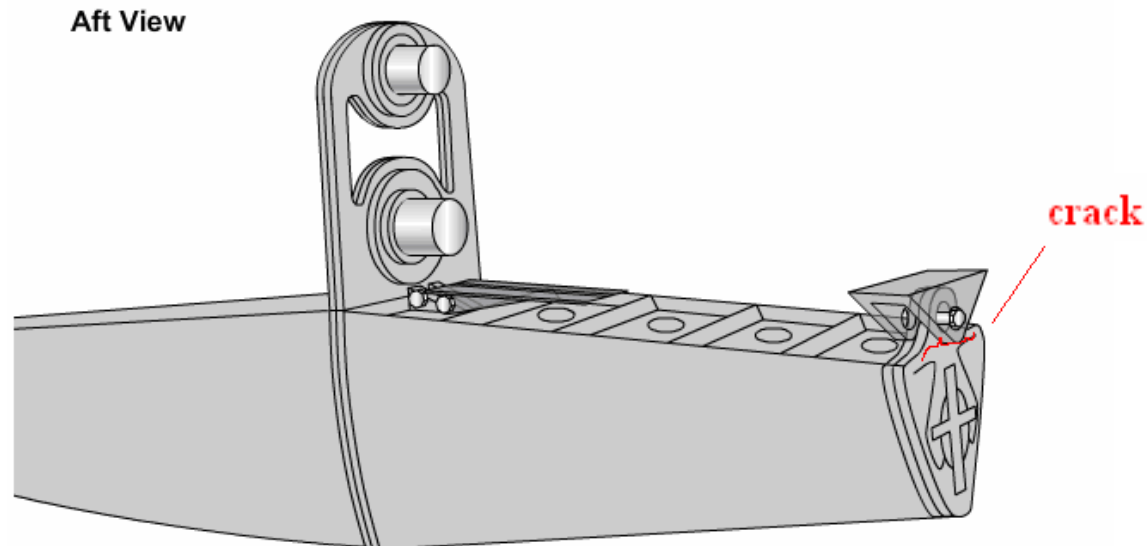
American Airlines mistakenly assumed that it is acceptable to remove/reinstall engine and pylon together. Based on such assumption, forklift was used for maintenance procedures and caused unintended structural damage during engine/pylon reinstallation. The damage led to the separation of the engine and pylon assembly at a critical point during takeoff.
